Evaluation of Damage to a Historic Masonry Building in Nepal through Comparison of Dynamic Characteristics before and after the 2015 Gorkha Earthquake

Aiko Furukawa^{1*}, Junji Kiyono¹, Rishi Ram Parajuli¹, Hari Ram Parajuli² and Kenzo Toki³

On April 25, 2015, a M_w 7.8 earthquake struck the Gorkha district of Kathmandu, Nepal. In Patan, vibrational characteristics of a 300-year-old two-story masonry building near Patan Durbar Square had been measured prior the Gorkha earthquake. In the inspection of the building after the Gorkha earthquake, several new cracks were found. The vibrational characteristics of the building were measured again, and it was found that the natural frequencies after the earthquake were smaller than those before the earthquake, indicating the reduction of the stiffness. Finite element models of the structure representing pre- and post-earthquake conditions are established so that the natural frequencies match the pre- and post-earthquake measurements and the structural damage is identified based on the stiffness reduction. Finally, the dynamic analysis of the finite element model of the building in the pre-earthquake condition using the observed ground mot

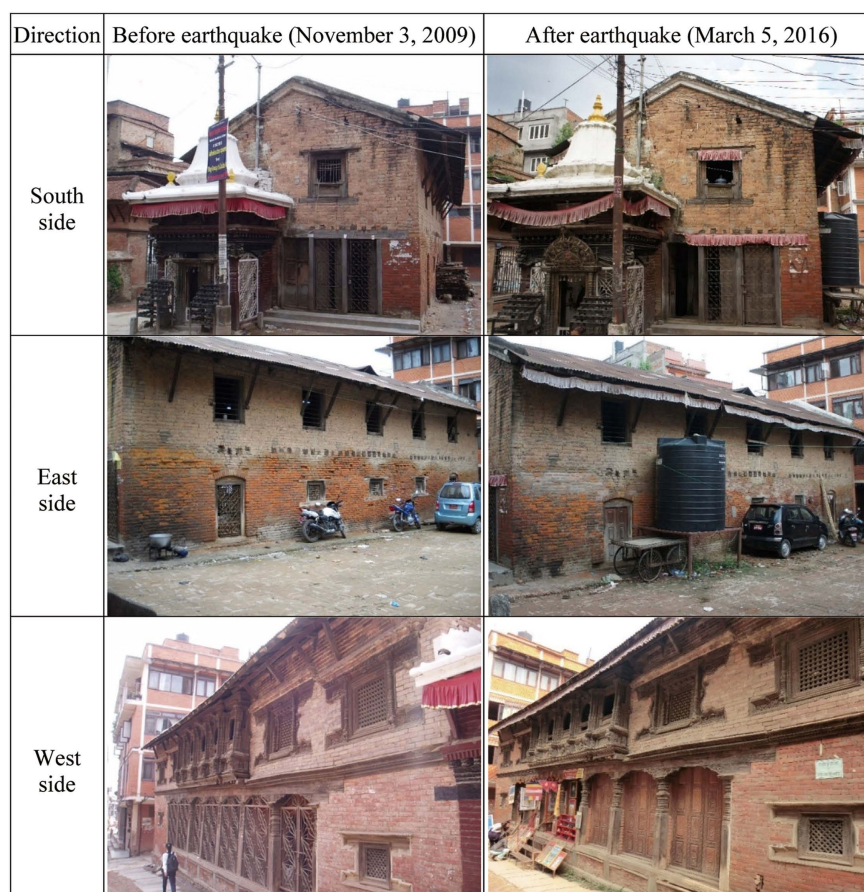
Figure 3 shows the comparison of the building appearance from the outside before and after the 2015 Gorkha earthquake. The pictures on the left were taken before the earthquake in November of 2009, and the pictures on the right were taken after the earthquake in March of 2016. Although many minor cracks in mortar were visible during the survey in March of 2016, most of those minor cracks were already present in the photo taken in 2009, and it was difficult to find out new cracks from the outside of the building. Then visual inspection of the cracks inside the building was carried out. Several cracks were found on the both ground and first floors as shown in Figure 5. Although no comparable photos taken prior to the earthquake are present, those cracks appeared to be new. In Figure 5, some walls resemble concrete walls, but they are brick walls covered with plaster. In addition to the cracks shown in Figure 5, several cracks were found on the ceiling of the GF and the timbers were seemingly deteriorated on the RF. Nevertheless, it was difficult to distinguish the damage

FIGURE 3 | Appearance of building before and after the 2015 Gorkha earthquake.

that already existed before the earthquake through the visual inspection.

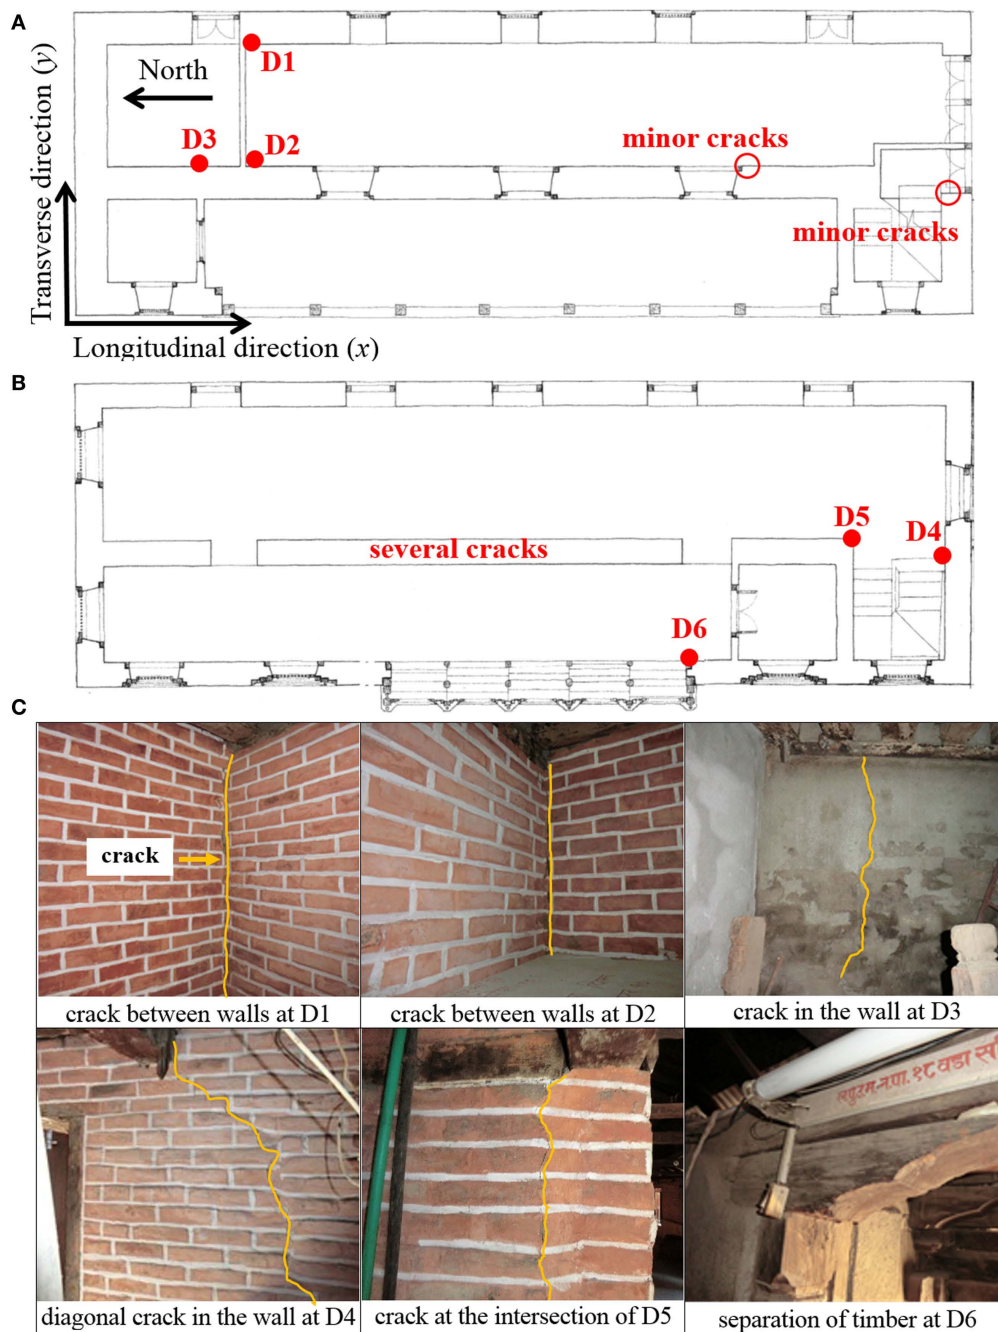
FIGURE 5 | Location and photographs of cracks found in the building after the 2015 Gorkha earthquake. **(A)** Location of cracks in the ground floor. **(B)** Location of cracks in the 1st floor. **(C)** Photographs of cracks found inside the building.

with the places where actual cracks were found in the post-earthquake inspection of the target building as already shown in **Figure 5C**. In this section, the distribution of shear strain is selected since it is found that large shear strain takes place where the actual cracks were found in the post-earthquake inspection.

It was found that the natural frequencies of the lowest 8 modes decreased by 3.46 to 11.86%, indicating structural damage. In a post-earthquake inspection of the building, several cracks were found on the ground and first floors.

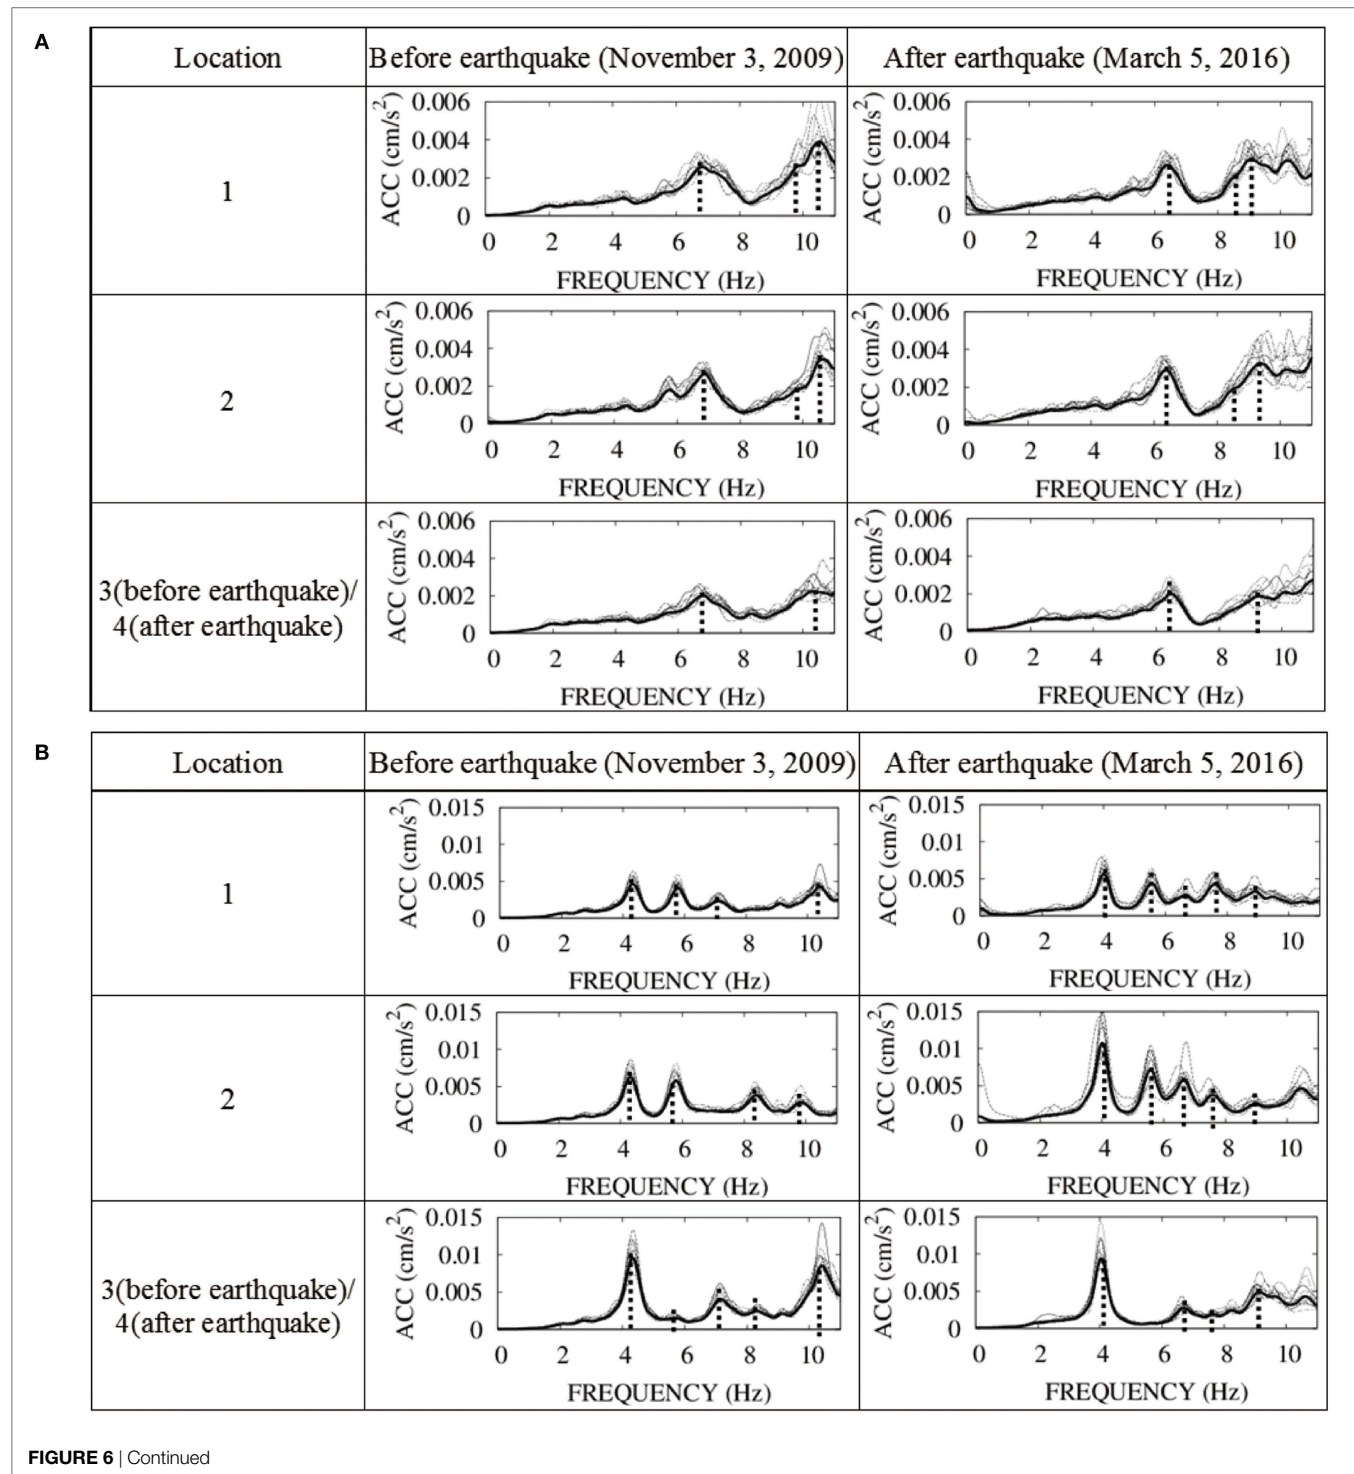
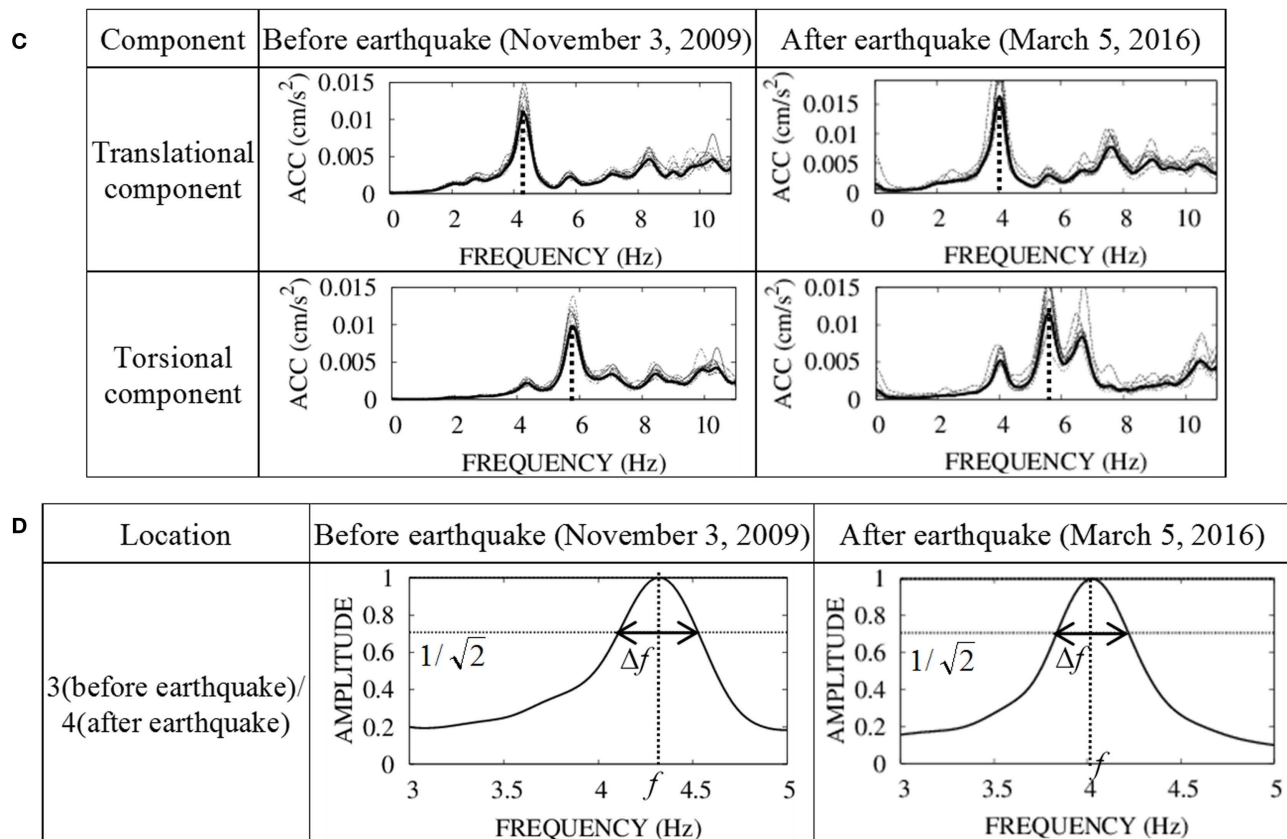
**FIGURE 6 |** Continued

Figure 6A shows a comparison between the Fourier amplitudes of the first-floor responses in the longitudinal (x , NS) direction before and after the earthquake. In **Figure 6A**, peaks can be seen at around 6.87 and 10.5 Hz before the earthquake and 6.43 and 9.2 Hz after the earthquake. It is reasonable to assume that these frequencies correspond to the natural frequencies of the dominant modes in the longitudinal direction before and after the earthquake. A slight peak can also be seen at locations 1 and 2 around 9.7 Hz before the earthquake and 8.5 Hz after the earthquake.

before and after the earthquake. In **Figure 6B**, peaks can be seen at 4.33, 5.78, 7.13, 8.4, and 10.2 Hz before the earthquake and 4.02, 5.58, 6.68, 7.64, and 9.0 Hz after the earthquake. These frequencies are considered to be the natural frequencies of the modes in the transverse direction. A greater number of the peaks can be seen in the Fourier amplitudes of the response in the transverse direction than that in the longitudinal direction. To further understand these details, the responses were separated into the translational and torsional components.

Figure 6C shows the sum and difference of the Fourier amplitudes at locations 1 and 2 in the transverse (y, EW) direction for pre- and post-earthquake measurements. Because the sum and the difference emphasize the translational motion and the torsional motion, respectively, it is found that the natural frequency of the translational motion is 4.33 Hz before the earthquake and 4.02 Hz after the earthquake. It can also be said that the natural frequency of the torsional mode is 5.78 Hz before the earthquake and 5.58 Hz after the earthquake.

The damping ratio of the first transverse mode is calculated by the half-power method under the assumption of white noise excitation. **Figure 6D** shows the normalized Fourier amplitude around the natural frequency of the first transverse mode. The dashed line indicates an amplitude of $1/\sqrt{2}$. The damping ratio h is obtained as $h = \Delta f/2f$ where f is the natural frequency and Δf is the frequency band width shown in **Figure 6D**. The damping ratios before and after the earthquake are found to be 4.82 and 4.85%, respectively.

Comparisons of the natural frequencies of the lowest eight modes and the damping ratios of the first transverse mode are shown in **Tables 1** and **2**. All of the modes indicate the decrease of the natural frequencies by 3.46 to 11.86% after the earthquake. The structural damage due to the earthquake is evidently shown by the stiffness degradation suggested by this result.

Comparison of ambient vibration of the building before and after the 2015 Gorkha earthquake. **(A)** Longitudinal (x, NS) direction. **(B)** Transverse (y, EW) direction. **(C)** Translational and torsional components in the transverse (y, EW) acceleration. **(D)** Damping ratio estimation based on the half-power method.

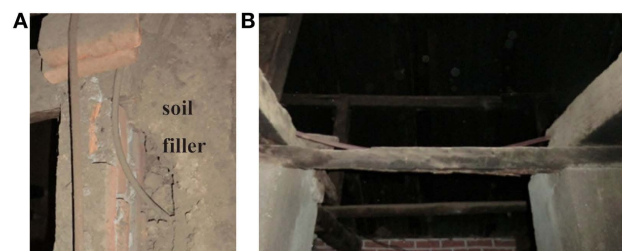
Figure 8A that shows the middle wall on the first floor taken from the above, soil filler can be seen. The timber stiffness also is overestimated, seemingly due to the deterioration of the

FIGURE 8 | Possible reason of overestimate of stiffness parameters. **(A)** Soil filled inside the brick wall. **(B)** Deterioration of timbers and imperfect connection.

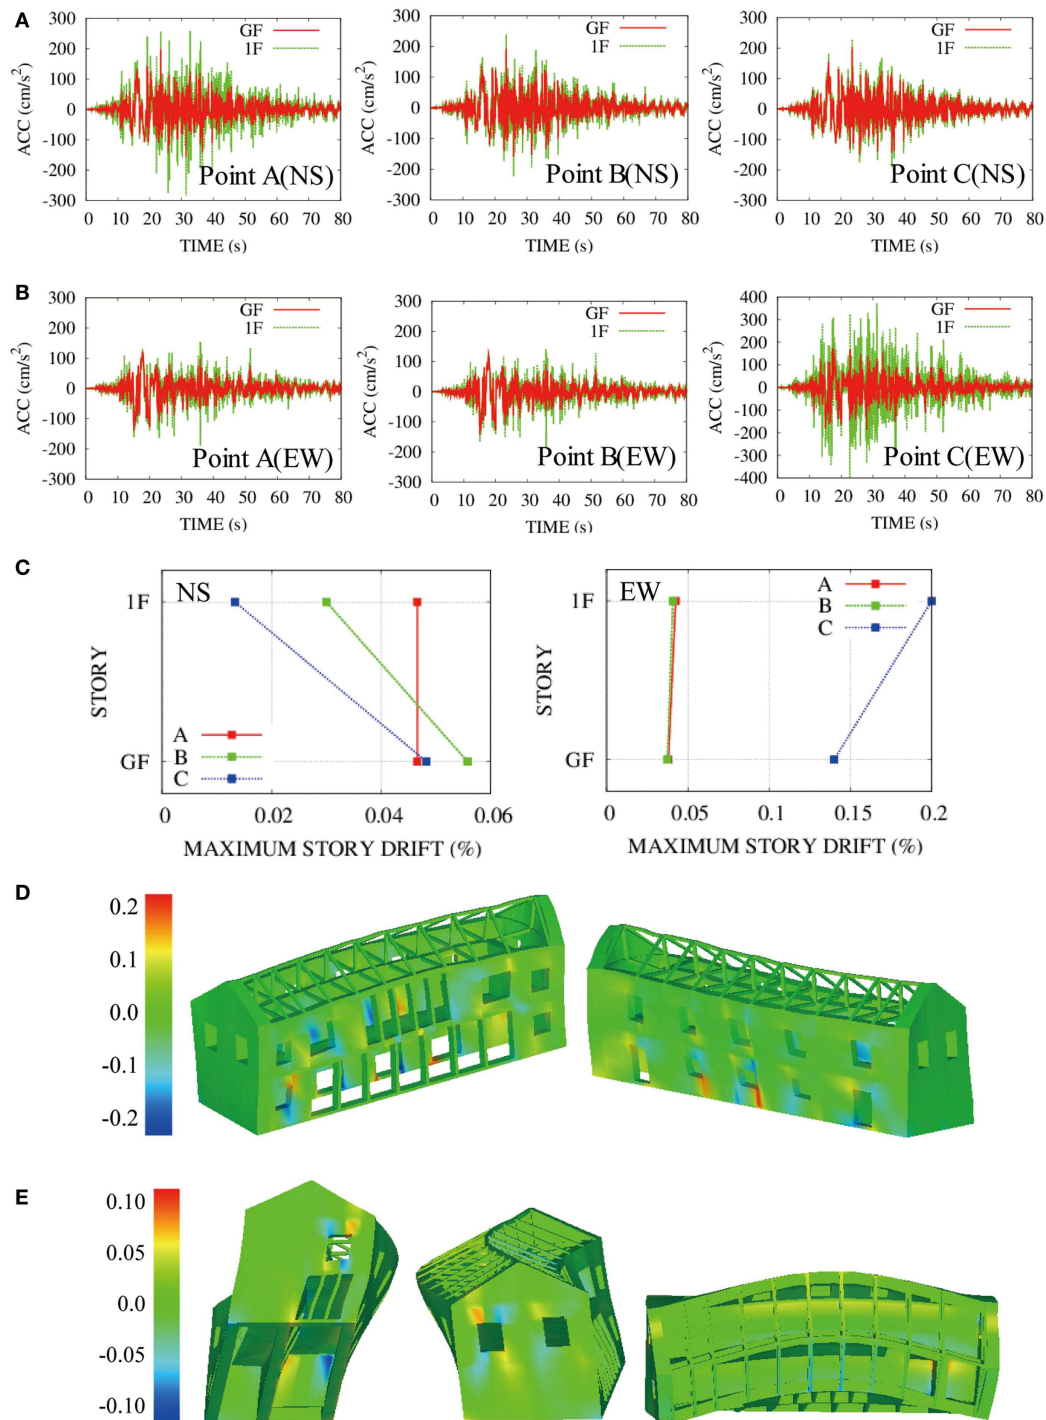
FIGURE 11 | Results of the dynamic analysis. **(A)** Acceleration response in NS direction. **(B)** Acceleration response in EW direction. **(C)** Maximum story drift. **(D)** Shear strain distribution in the xz-plane at 26 s. **(E)** Shear strain distribution in the yz-plane at 29 s.

On the other hand, when the building deformation is in the y direction, significant shear strain of yz -component is observed near the corner of openings in the short side walls as shown in **Figure 11E**. It is noteworthy that considerable shear strain takes place on both sides of the partition walls on the GF and at the intersection of two inner walls. These parts coincide

The location of structural damage found in the post-earthquake inspection is successfully explained by the shear strain distribution.
